**TOWNSHIP OF LEEDS AND THE THOUSAND ISLANDS**

**Escott Waste Disposal Site  
2018 Annual Monitoring, Development and  
Operations Report**

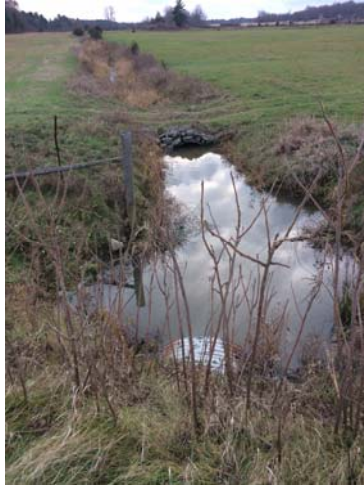
Surface Water Location: SW4  
12-Nov-2018

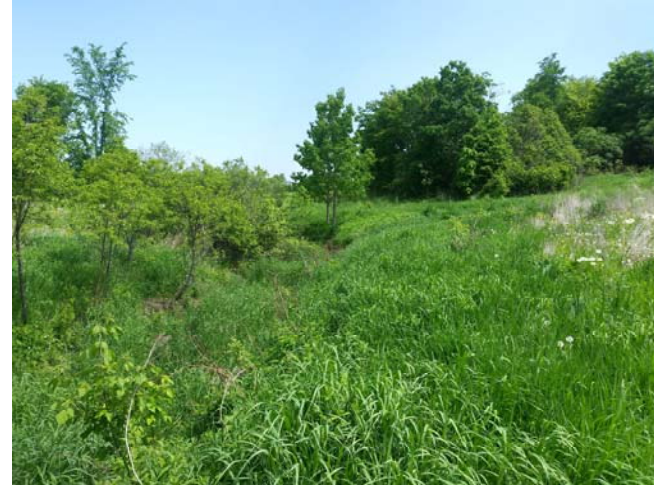
Results downstream at SW5 displayed slightly higher concentrations of some LIPs when compared to background during the spring event. These include ammonia, iron, and manganese. However, the concentrations of these parameters decreased in the fall. Given this station has not shown evidence of leachate in the past, we continue to believe that there is not a significant leachate influence at the stream. Elevated LIPs observed in the spring could be related to agricultural activities and runoff in the area. Further monitoring of potential trends will be evaluated in 2019.

Surface Water Location: SW5  
30-May-2018

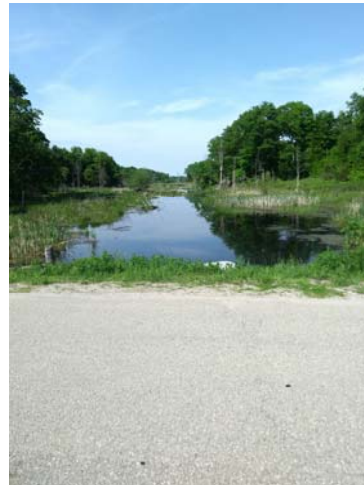
The south stream is approximately 375 meters south of the waste pile. The flow direction of the stream is to the northeast. Sampling stations SW7 and SW8 are located along this stream. SW7 is used to characterize the background due to its up-stream location. It should be noted that SW7 is also located next to the main road (Escott Rockport Road).

Surface Water Location: SW7  
30-May-2018

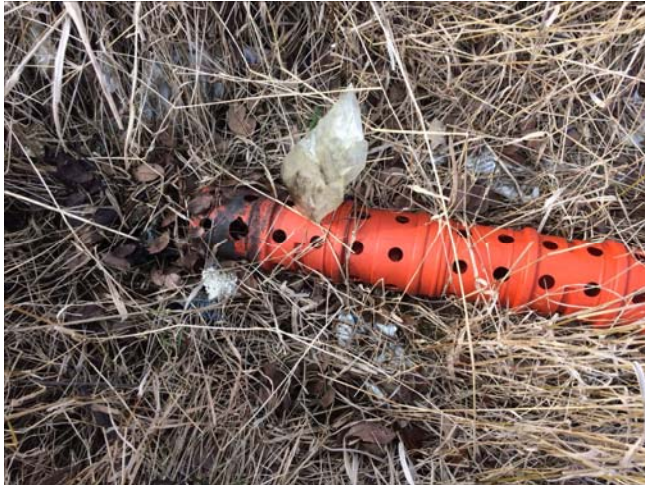
Dry conditions were reported at HBI during both sampling events. During the fall, HBO exhibited elevated levels of hardness, alkalinity, conductivity, and TDS when compared to backgrounds. However, given no metal or other LIPs were elevated, we suggest that these parameters indicate a non-leachate related influence to surface water quality.

Surface Water Location: HBI  
12-Nov-2018

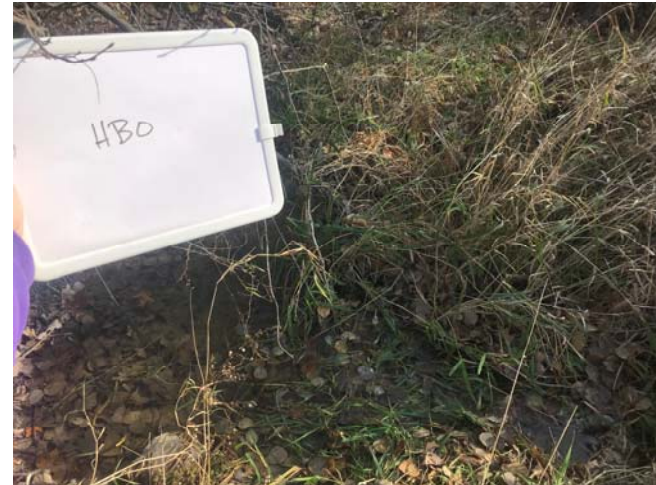
Surface Water Location: HBO  
12-Nov-2018

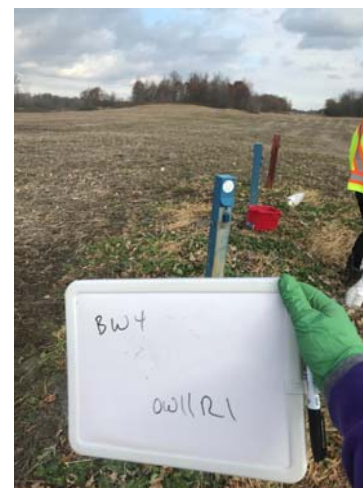
Well ID: OW11R1  
12-Nov-2018

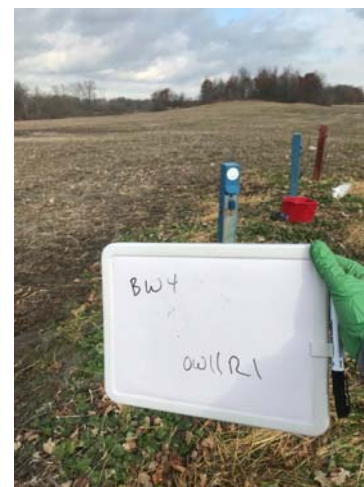
*Malroz* recommended to the MECP, in an email dated November 8, 2018, that monitoring well OW11 should be abandoned in accordance to Regulation 903, citing damage to the well's seal. A replacement well (OW11R1) has already been installed and will remain on the monitoring program.

*Malroz* noted that monitoring wells OW8 and OW11 are still present at the Site and are recommended for abandonment. Replacement wells OW8R1 and OW11R1 have already been installed.

Well ID: OW11R1 (front),  
OW11(middle), BW4 (back)  
12-Nov-2018

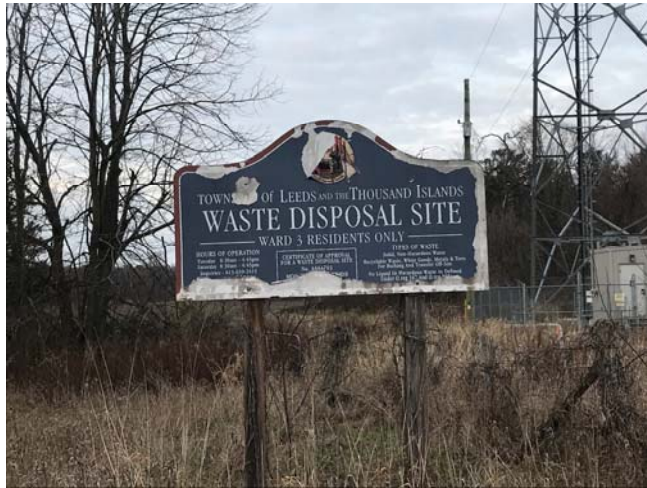
Ponding was reportedly often observed at the Site following a rain event. The entrance signage is beginning to show signs of degradation. *Malroz* also noted that signs at the Site do not direct vehicles to the working face, the recycling bins, and other disposal areas at the Site. We have provided this information to TLTI and recommend that this be addressed.

Entrance signage  
12-Nov-2018

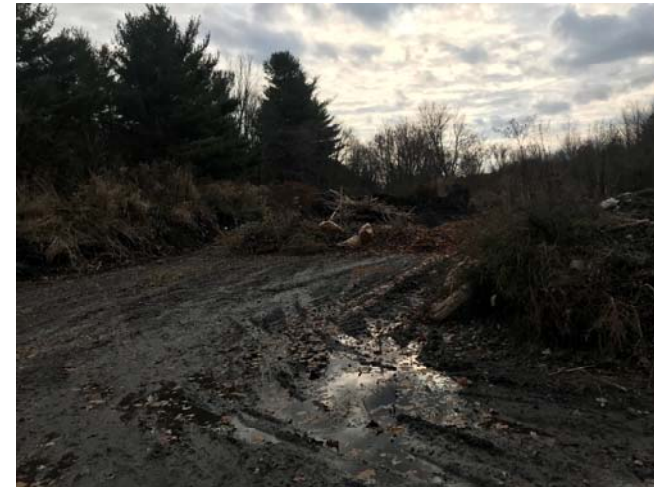
The WDS relies on natural attenuation. There are no engineered systems for leachate collection or storm water management, other than a ditch located along the north-western edge of the waste mound. However, ponding along the ditch suggests that it may need re-grading. The Site has been approved to burn clean wood waste (CofA 23(b)), following the MECP's Guideline C-7 entitled "Burning at Landfill Sites". We understand, from discussion with TLTI personnel, that burning occurs once per month at the Site, weather permitting. Based on the attendant logs, no spills or emergencies occurred at the Site in 2018.

Brush pile and ponded water  
12-Nov-2018

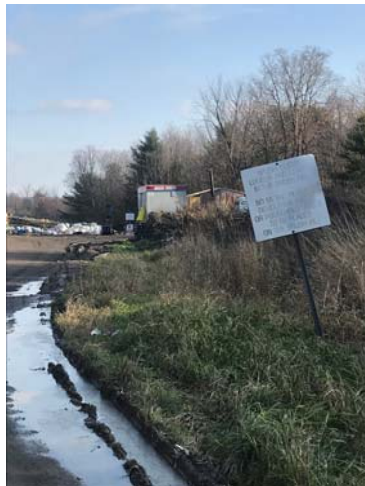
Ponded water at entrance  
12-Nov-2018

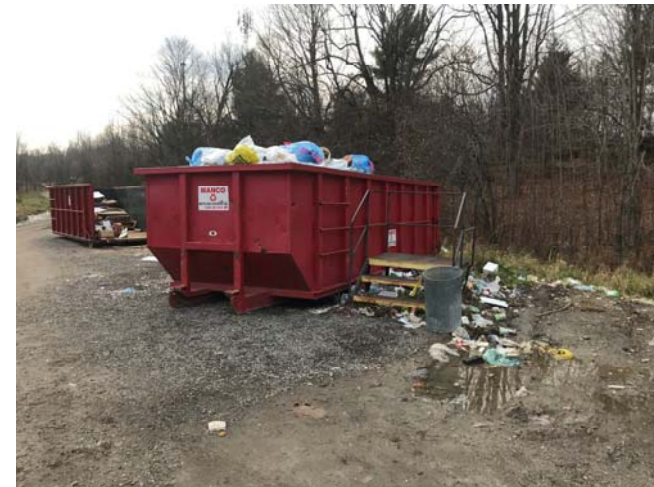
Plastic recycling bin and wind-blown waste  
12-Nov-2018

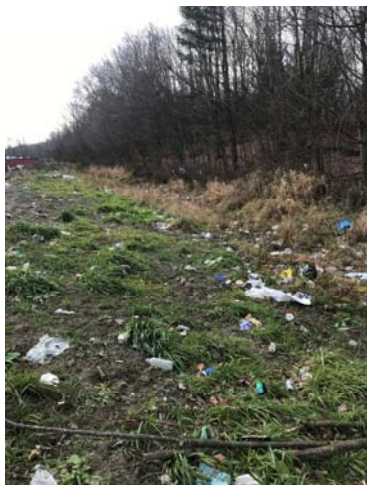
Wind-blown waste along west  
property line  
12-Nov-2018

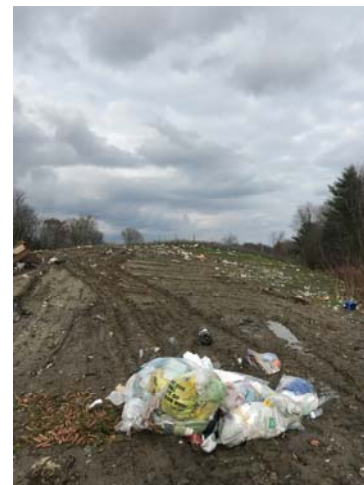
Active filling area  
12-Nov-2018
